Manhole Inspection Summary

Manhole # S37W1_017MH

Insp Date: **6/20/08 9:00 AM**

Location Address: **100 E. patapsco Ave.**

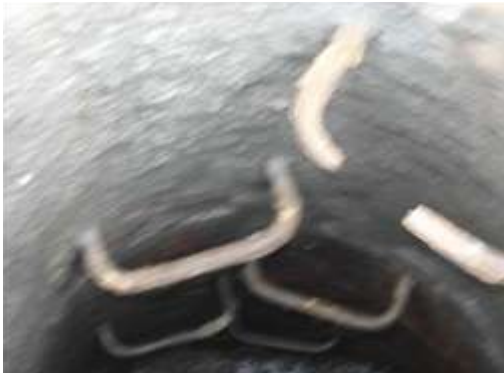
Steps

Count: **4** Missing: **1** ☒ **Corroded**

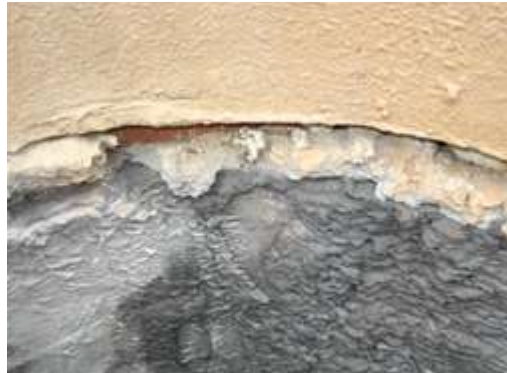
Defect 1

Condition: ☐ Sound ☒ **Cracked** ☐ Root Intrusion ☐ Loose Brick ☐ Deteriorated

Infiltration: ☐ None ☒ **Joint** ☐ Cracks ☐ Mortar ☐ Roots ☐ Wall

Frame-Chomney joint.

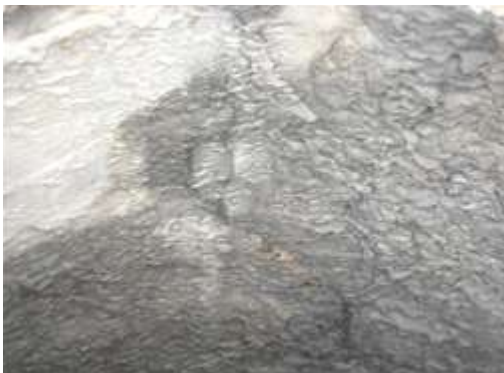
Defect 2

Infiltration: ☐ None ☐ Joint ☐ Cracks ☐ Mortar ☐ Roots ☒ **Wall**

Infiltration

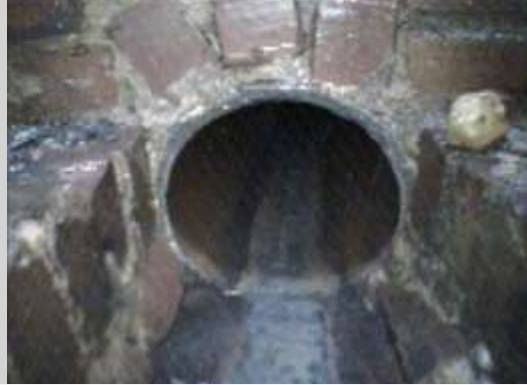
12 O'Clock Outflow

Pipe Height: **8.4** (in.) Rod and Bar (Angled)
Pipe Material: **Clay** ☐ Pipe Lined
Invert Depth: **11.22** (ft.) Flow Characteristics: **Slow**
Deposits: ☒ None ☐ Mud ☐ Sludge ☐ Debris ☐ Grease
Silt Depth: (in.) Deposits Extent:
Infiltration: **None** Pipe Seal Cond: **Sound**

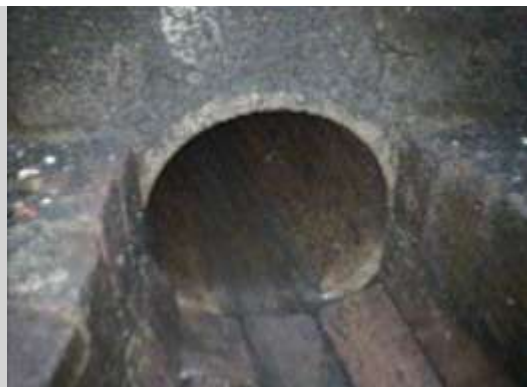
4 O'Clock Inflow

Pipe Height: **8.4** (in.) Rod and Bar (Angled)
Pipe Material: **Clay** ☐ Pipe Lined
Invert Depth: **11.16** (ft.) Flow Characteristics: **Fast**
Deposits: ☒ None ☐ Mud ☐ Sludge ☐ Debris ☐ Grease
Silt Depth: (in.) Deposits Extent:
Infiltration: **None** Pipe Seal Cond: **Sound**
